Rural Municipality of  
**WEST RIVER**

## Building Condition Assessment – Lloyd Inman Park

February 8, 2024

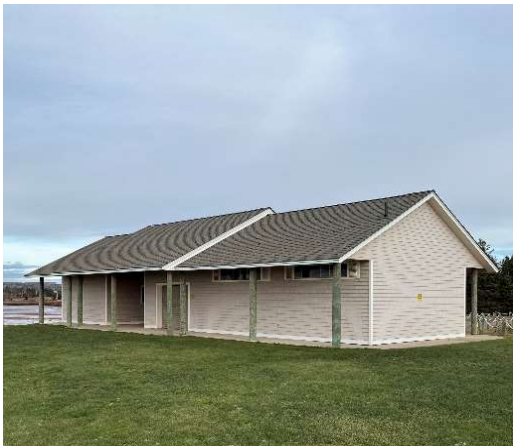
Figure 1 – Rear Exterior of Large Building

In general, the exterior of the main two builds is in good condition. The roofs, siding and doors have been recently updated appear to be in good condition. The concrete walkways in the building are in good condition. The roofs on the small canopy structures are showing signs of decay and should be replaced within five years.

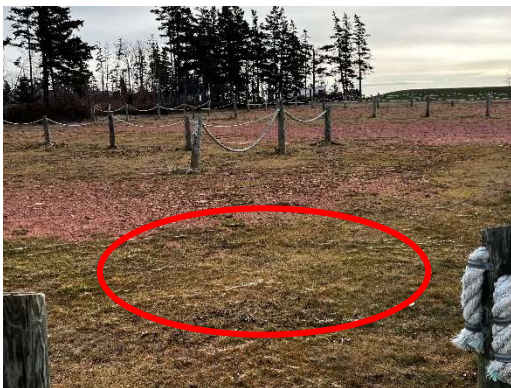
Figure 3 – Main Parking Lot

The site drainage appears fair with signs of water pooling or rapid water flow. That said, because the terrain is relatively flat, there is likely water pooling during periods of heavy rain. The parking area is in less than fair condition. There are uneven surfaces throughout the parking area and larger potholes at the entrance. Vegetation has breached from around the perimeter in a few places, covering a significant portion of the parking area. Grading the driveway and parking area is recommended.

Project Description	Recommended Budget	Recommended Timing	Comments
Fill the potholes and grade the driveway and parking area within the next two years	\$4,000	2026	Potholes and vegetation throughout the driveway and parking area.

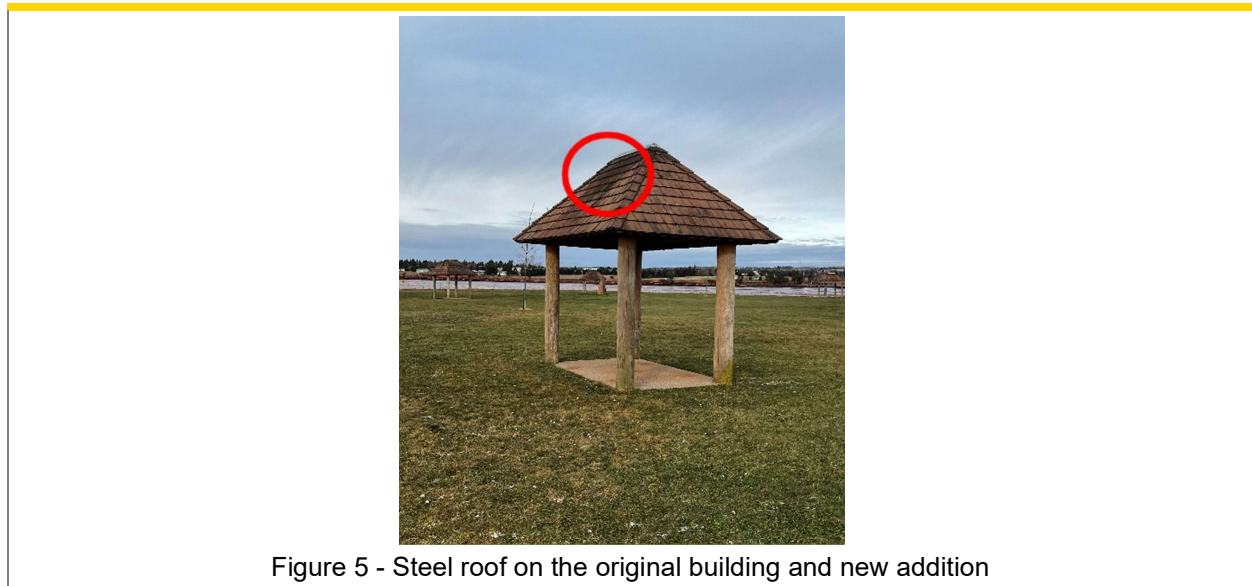
The shingled roof on each of the main structures was observed from ground level and appeared to be in good condition. It was assessed that there are no significant expenditures anticipated with the roofs of the two main buildings within the timeframe of this report. The shingles on the five small canopy structures appear to be discolouring and in need of replacement.

Figure 5 - Steel roof on the original building and new addition

Project Description	Recommended Budget	Recommended Timing	Comments
Replace shingles on the five small canopy structures within five years.	\$10,000	2029	Shingles on five small canopy structures appear to need replacement.

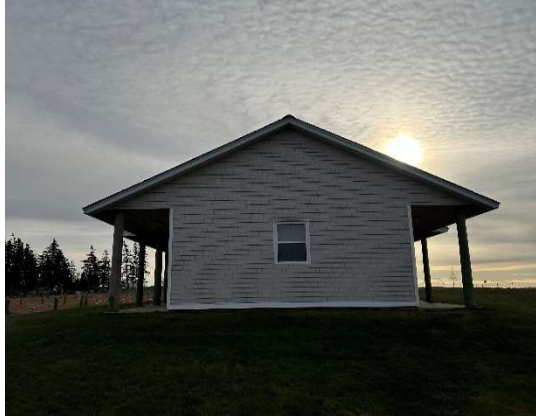
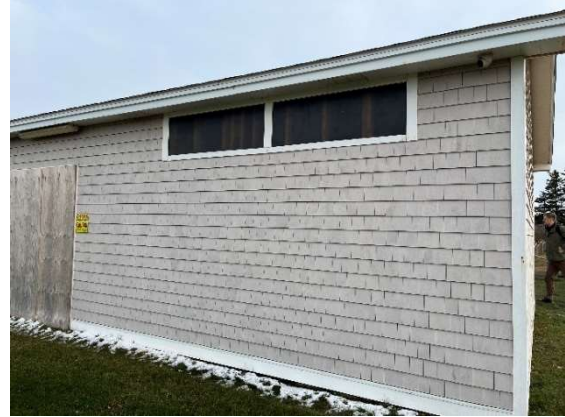
The windows on the two main buildings are original and appear to be in good condition. Replacing the windows within six years is recommended.

Figure 6 – Original Windows in Both Buildings

Figure 7 – Original Windows in Both Buildings

Project Description	Recommended Budget	Recommended Timing	Comments
Plan to replace within the next six years.	\$7,000	2029	Windows are original to each of the buildings and appear to be in good condition.

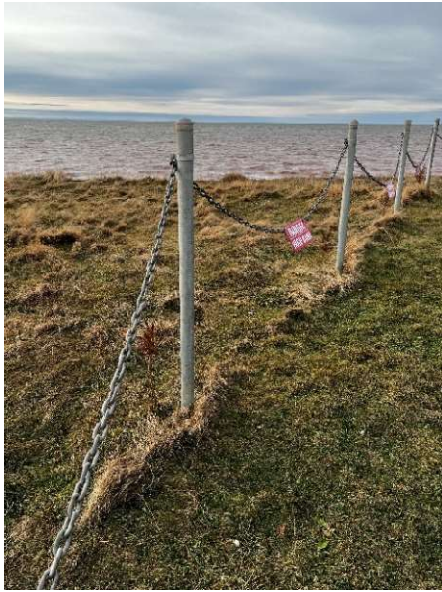
The exterior fencing around the perimeter of the property appears to be in good condition. Continue to inspect for rust and plan to replace it within ten years. Polypropylene rope fencing around the perimeter of the parking lot is beginning to fray in some areas. Some wooden posts are beginning to decay. Plan to replace it within four years is recommended. The playground equipment appears to be in good condition with it having been replaced three years ago. The swing set appears in fair condition with small areas of rust starting to form. Continue to inspect for rust and plan to replace it within fifteen years.

Figure 8 – Cliff Perimeter Metal Fencing

Project Description	Recommended Budget	Recommended Timing	Comments
Inspect for rust and plan to replace it within ten years.	\$5,000	2034	Chain fencing around the perimeter of the property appears to be in good condition.
Plan to replace the rope and posts within four years.	\$3,000	2028	Polypropylene rope fencing around the perimeter of the parking lot is beginning to fray in some areas. Some wooden posts are beginning to decay.

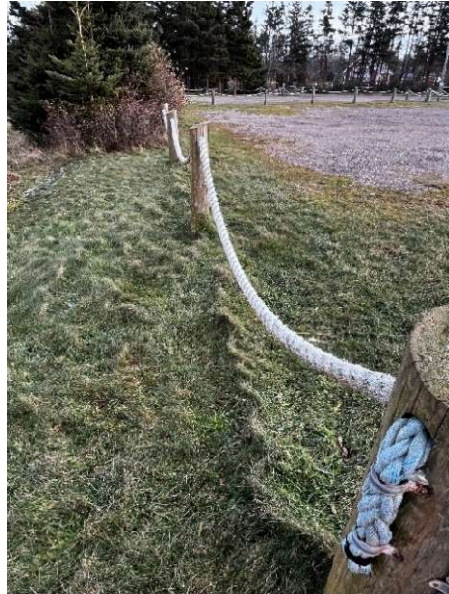
Figure 9 – Parking Perimeter Rope Fencing

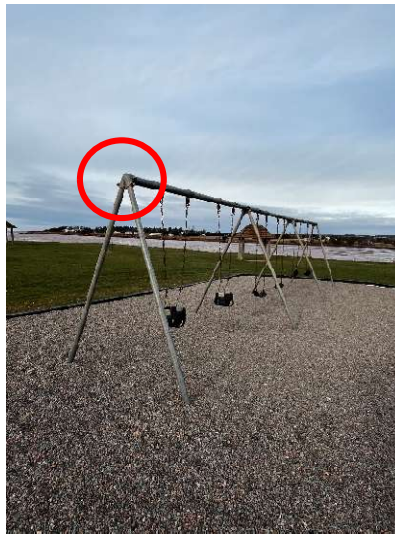
Figure 10 – Rust Forming on Swing Set

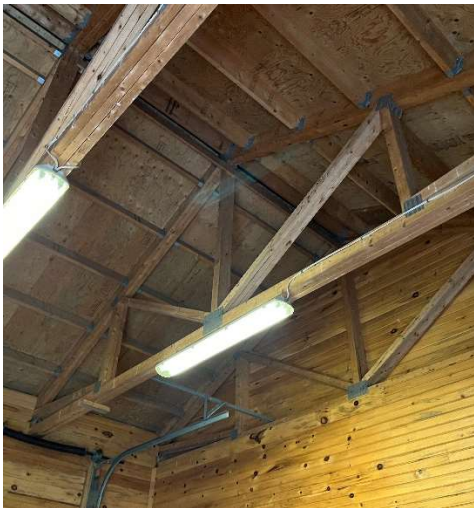
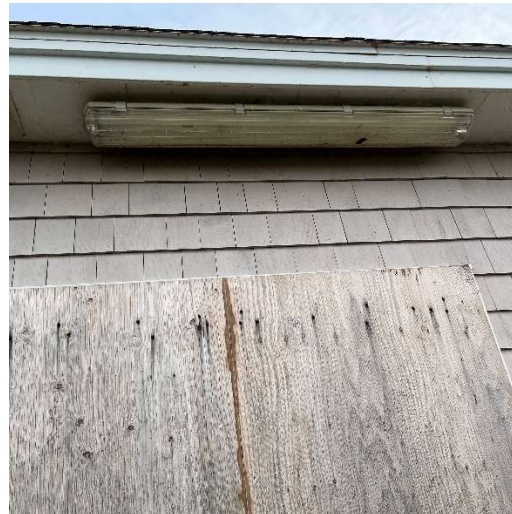
There are no obvious issues with lighting. For fluorescent lights, ballast can start to fail around the 15-year point (depending on building moisture). These lights will likely not fail all at once, but it is possible that there will be a period of three or four years where they fail regularly and will require replacement.

Figure 11 – Fluorescent Ceiling Lights

Figure 12 - Exterior Fluorescent Lights

Project Description	Recommended Budget	Recommended Timing	Comments
Replace the lights as needed.	\$2,500	2029	Interior and exterior lighting appears to be in good condition.

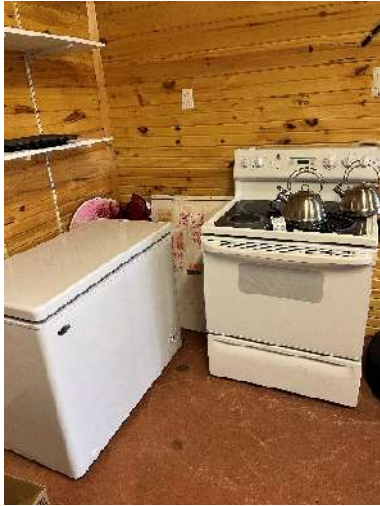
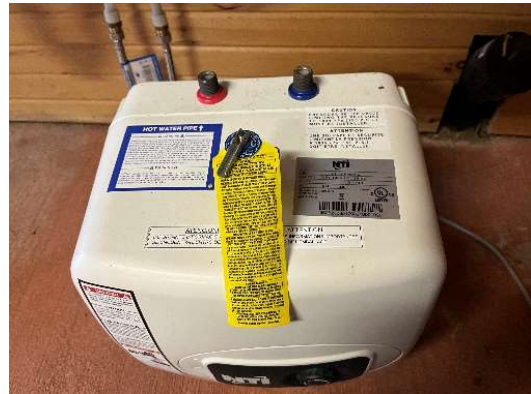
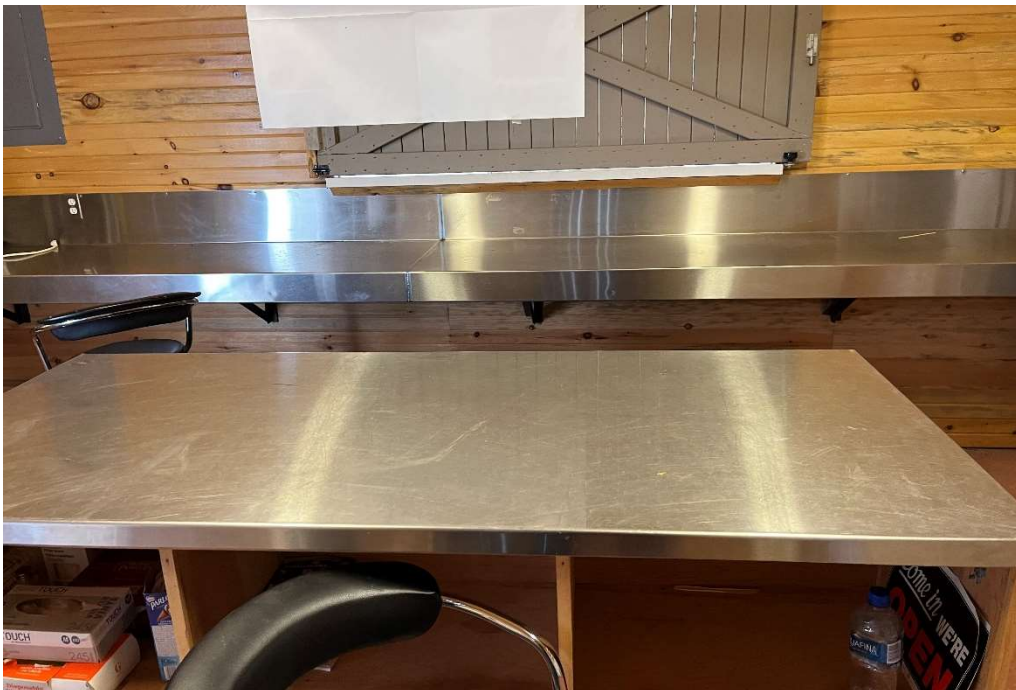
The kitchenette is in good condition and serves as a canteen and community kitchen well. The appliances (oven, refrigerators/freezer, and water heater) are in good condition (although the water heater model is currently discontinued by the supplier). The area would require assessment by kitchen equipment experts to provide a definitive end-of-life recommendation.

Figure 12 – Kitchenette appliances

Figure 13 – Compact water heater

Figure 14 – Counter space and service window

Project Description	Recommended Budget	Recommended Timing	Comments
The kitchenette and equipment appear to be in good condition.	\$7,000	2029	Continue to inspect for rust and plan to replace it within ten years.

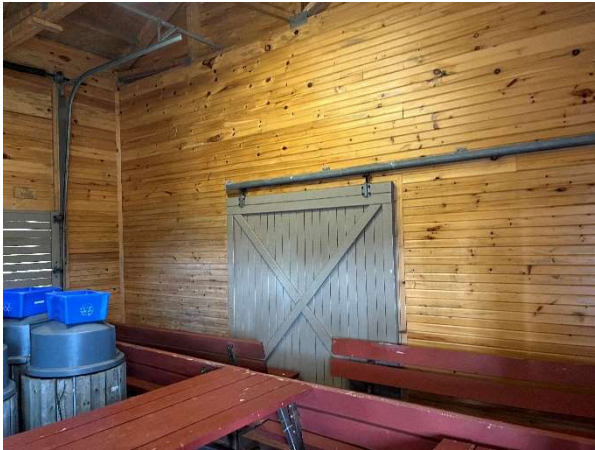
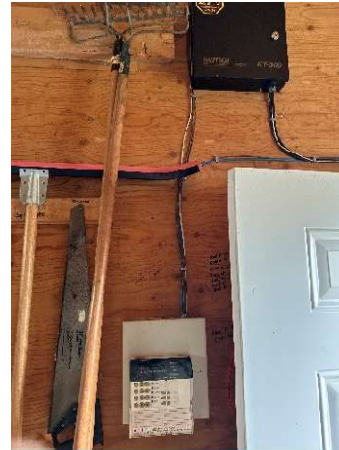
The interior finishes of the building are in good condition. The ceilings also appear to be in good condition and will likely only require general maintenance and upkeep.

Figure 15 – Interior walls in publicly accessible areas.

Figure 16 – Storage area interior walls.

Project Description	Recommended Budget	Recommended Timing	Comments
Interior walls appear to be in good condition.	\$9,000	2029	Continue to inspect for rust and plan to replace it within ten years.

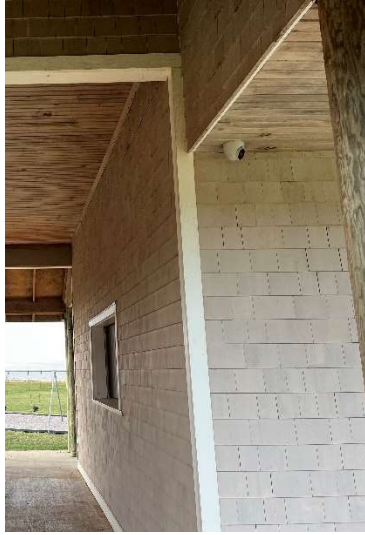
Figure 17 – Security Camera

Lloyd Inman Park is not equipped with a wet or dry sprinkler system. A fire services professional should be consulted to determine code compliance as well as any requirements for a joint-use municipal building. The security system has been replaced in the last ten years. On average, the lifespans of cameras are approximately ten years.

Project Description	Recommended Budget	Recommended Timing	Comments
Security Cameras appear to be in good condition.	\$1,500	2026	Security cameras generally have a ten-year lifespan. Replace within the next two years.

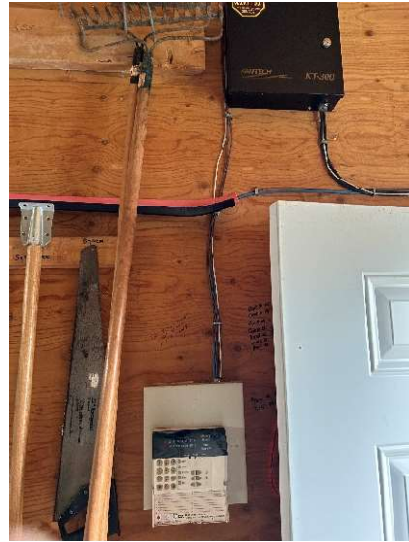
Figure 18 - Mechanical system alarm.
