Rural Municipality of
WEST RIVER

Building Condition Assessment – Afton Community Centre

February 8, 2024

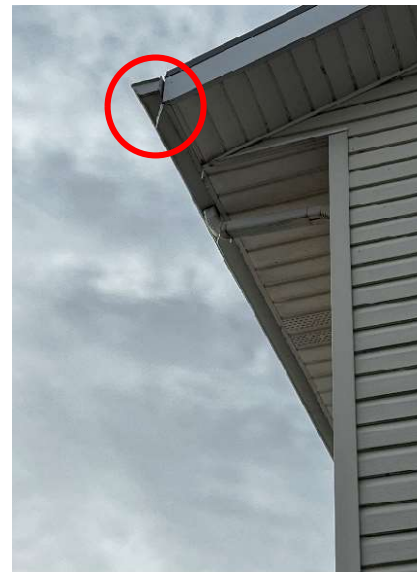
Figure 2 – Fascia Separating

Project Description	Recommended Budget	Recommended Timing	Comments
Check entire building exterior, close any cracks or separations in siding or cladding and caulk around any suspected gaps. Power wash building and assess if painting is warranted.	\$2,500	2024	Siding is dirty and has some paint peeling. Several locations observed where the siding has been penetrated by affixed brackets, installed conduits or wind damage.
Be prepared to replace siding at the end of the 40 year life cycle.	\$50,000	2030	Siding showing evidence of cracking and fading.

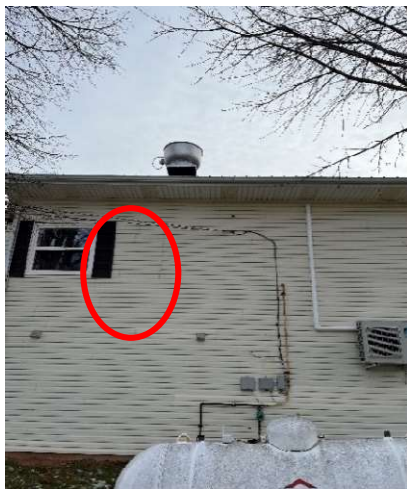
Figure 3 – Exterior of Siding at Kitchen

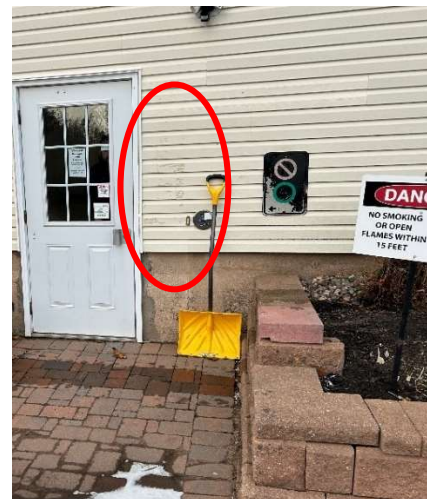
Figure 4 – Dirt Accumulation and Wear

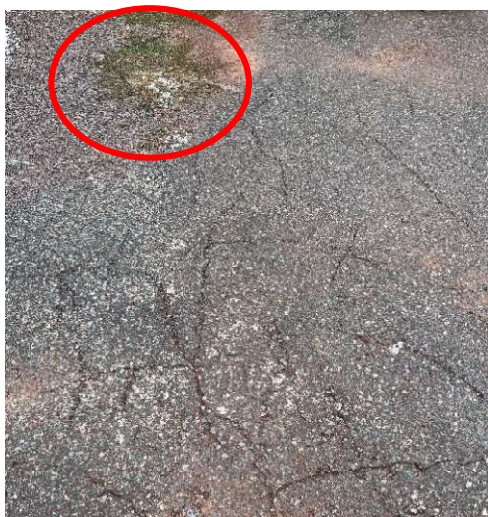
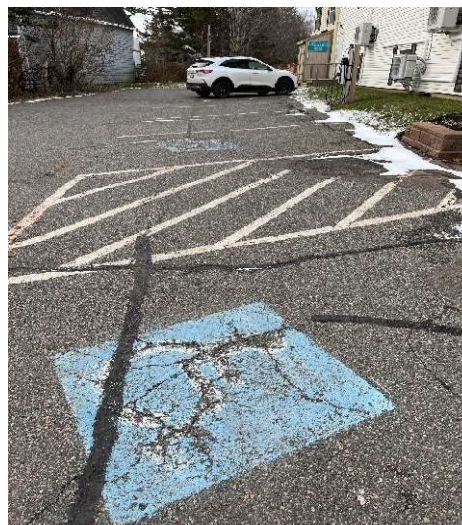
The site drainage appears to be adequate with no signs of significant water pooling or rapid water flow. That said, because the terrain is flat, there is likely water pooling during periods of heavy rain or rapid snow/ice melting. The asphalt parking area was in fair condition, but vegetation has breached the pavement in several places, some cracks have been repaired and the painted lines and symbols need to be re-painted.

Figure 5 – Main Parking Lot (East Side)

Figure 6 – Main Parking Lot (East Side)

Project Description	Recommended Budget	Recommended Timing	Comments
East side parking area - Remove old asphalt and re-pave parking area. Paint new lines and symbols.	\$16,224	2026	Vegetation penetration, repair sealing failure and minor cracking. Lines and symbols barely legible.
West side parking area - Remove old asphalt and re-pave parking area. Paint new lines and symbols.	\$27,371	2032	Evidence of repair sealing failure and some minor cracking. Lines and symbols barely legible.

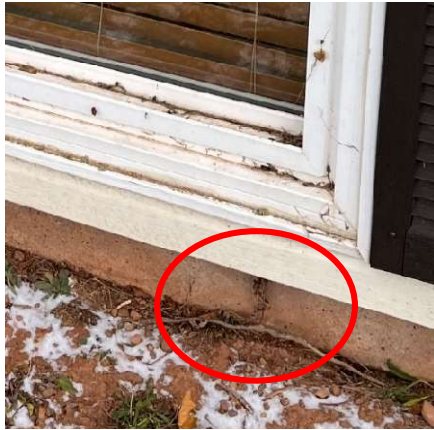
Figure 7 – Cracked Window Frame

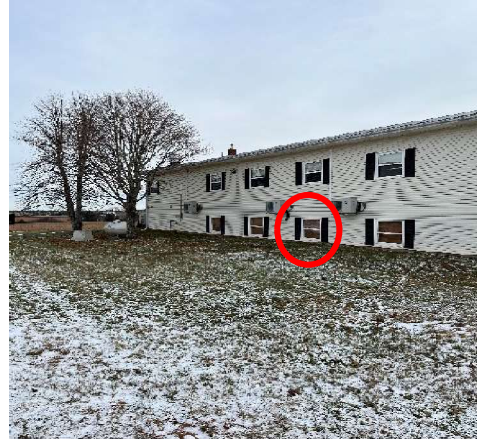
considered in this report. We observed one minor crack from the outside of the building but did not observe any signs of water penetration on the building's interior near that location. No other foundation cracks were observed. It was assessed that there are no significant expenditures anticipated with the foundation.

Figure 8 – Location of Foundation Crack

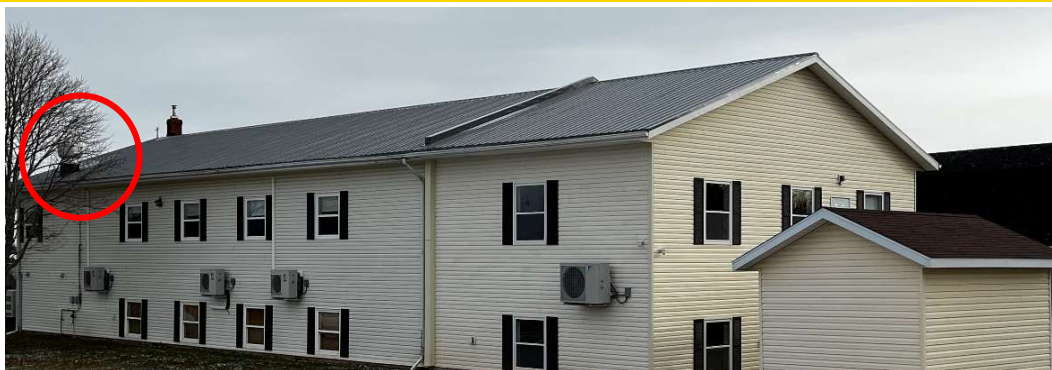
The steel roof was observed from ground level and appeared to be in good condition. Protrusions from the roof such as the kitchen vent will enable snow accumulation and could potentially contribute to a future leak in the roof. No evidence of leaking was observed inside the building.

Figure 9 - Steel Roof on Original Building and Addition

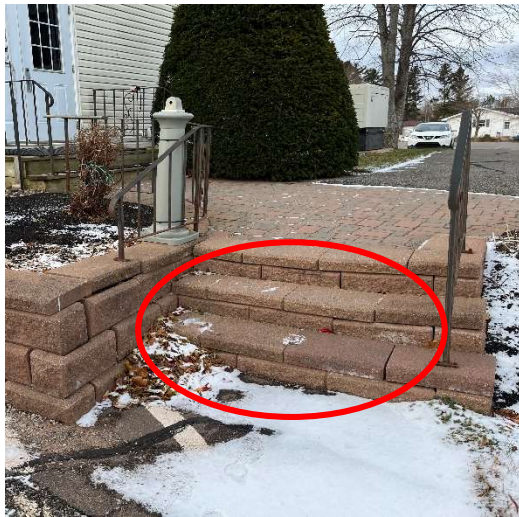
Figure 10 – Main Entrance - Steps Settling

Project Description	Recommended Budget	Recommended Timing	Comments
Immediate repair recommended.	\$2,500	2024	Slumping of the brick flagstones indicate settling. The unevenness of the steps presents a current safety issue to the public and staff.
Immediate replacement recommended.	\$3,000	2024	Exterior wooden steps, decking and handrails for side and front entrances.

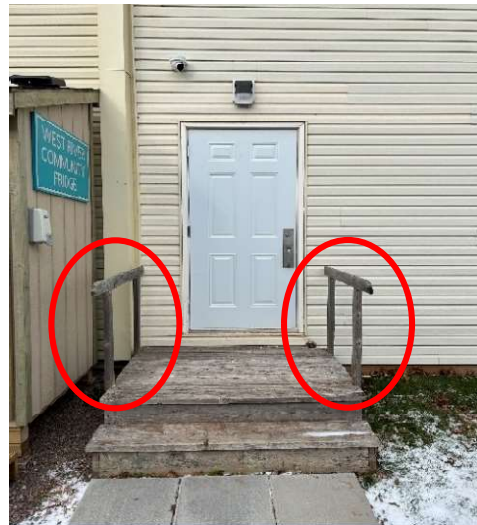
Figure 11 – Side Entrance to Elevator – Hand Rails and Steps

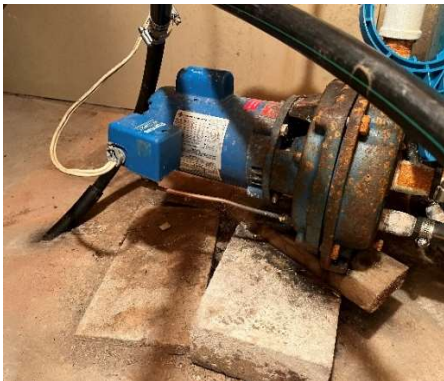
The water pump is close to the end of its life cycle and should be replaced by 2025. There is evidence of previous moisture damage, and it is recommended that the drywall and wood that is contaminated by mould be removed and replaced as soon as possible.

Figure 12 – Pump Near End of Life

Project Description	Recommended Budget	Recommended Timing	Comments
Replace domestic water pump and tank within the next two years.	4,500	2025	Pump and tank for well water are rusting.
Replace existing tank with a fiberglass oil tank within the next four years. Consult insurance provider.	\$4,000	2027	The oil tank was manufactured in 2007.
Expect to replace in the next ten years. Seek expert opinion.	\$10,000	2034	Buderus Cast Iron Oil Boiler, appears to be in good condition.
Expect to replace in the next ten years. Seek expert opinion.	2,5000	2034	Buderus water tank appears to be in good condition.

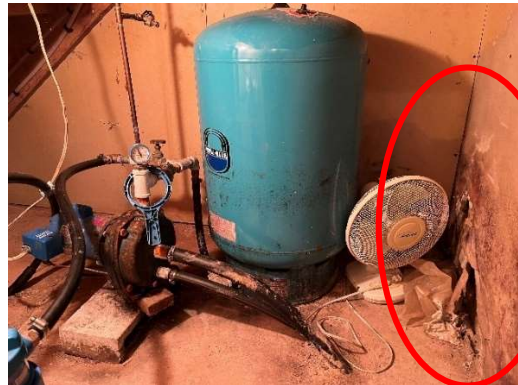
Figure 13 – Pump Area - Mould Removal and Repair Required

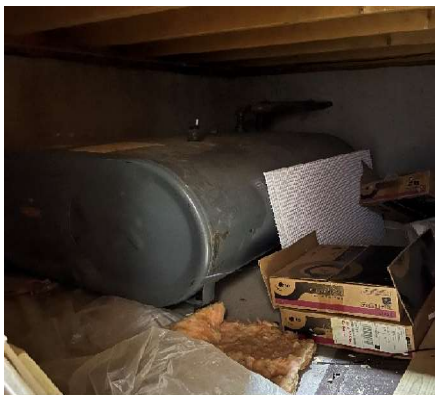
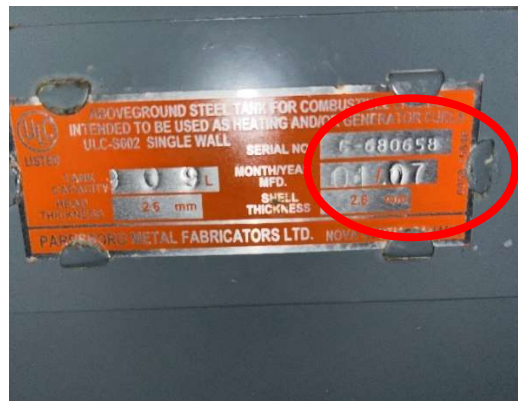
There is a steel oil tank currently inside the building that is difficult to access. The tag indicates a fabrication date of 2007. This tank will need to be replaced with another tank by 2027, and that should ideally be installed on the outside of the building. It is recommended that the building's insurance provider be consulted.

Figure 14 – Oil Tank Off the Mechanical Room

Figure 15 – Tank Tag (MFD April 2007)

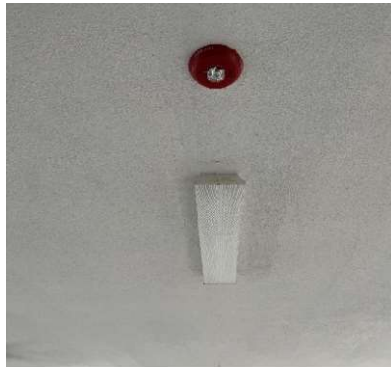
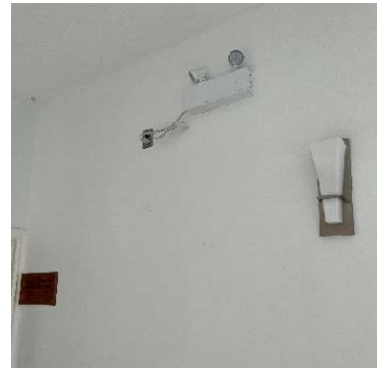
There were no observed concerns with lighting. For fluorescent lights, ballast can start to fail around the 15-year point (depending on building moisture). These lights will likely not fail all at once, but it is possible that there will be a period of three or four years where they fail regularly and will require replacement. It should be strongly considered to upgrade to LED lighting to reduce operations/electricity costs.

Figure 24- Fluorescent ceiling lights.

Figure 25 - Emergency Light and Wall Sconce

Project Description	Recommended Budget	Recommended Timing	Comments
Replace as required.	\$5,000	2026	Interior overhead lighting and emergency lighting approaching the end of life expectancy.

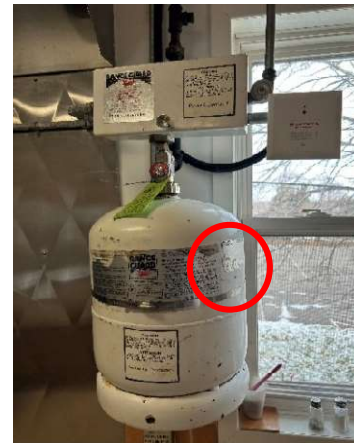
range hood fire suppression tank shows an inspection date of 2008, this should be inspected by a qualified person immediately if the kitchen is still in use.

Figure 29 - Fire Suppression Out of Date

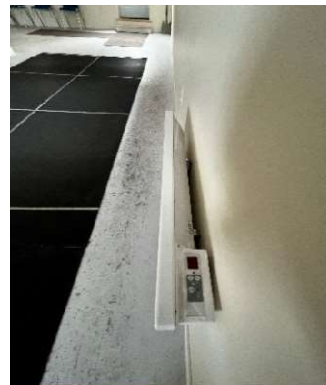
Figure 32 - Significant Wear - Side Entrance Hall

Project Description	Recommended Budget	Recommended Timing	Comments
Replace flooring in two stages – downstairs.	\$35,000	2025	Downstairs flooring is worn.
Replace flooring in two stages - upstairs.	\$35,000	2031	Upstairs flooring is in better condition than downstairs.

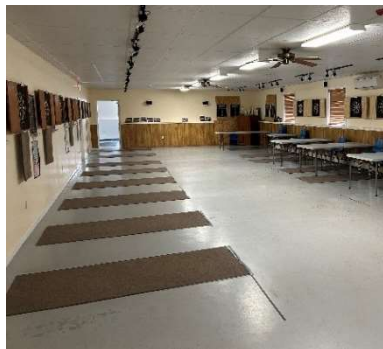
Figure 33 - Downstairs Multipurpose Room - Flooring Showing Signs of Wear

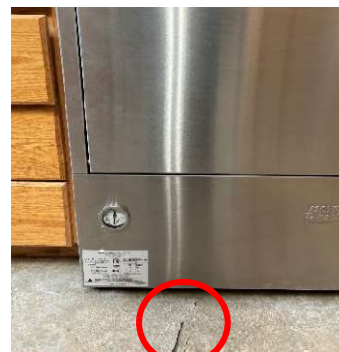
Figure 34 - Kitchen Floor Damaged

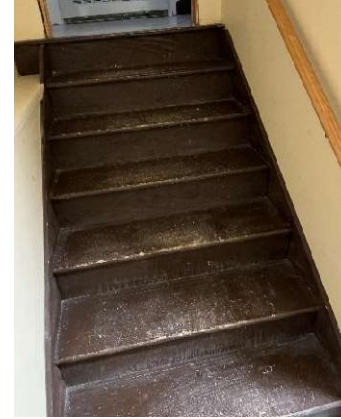
Figure 36 - Wooden Stairs Require Paint

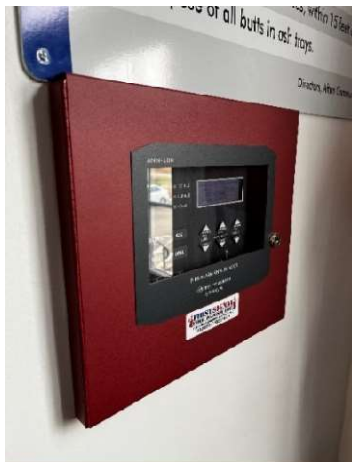
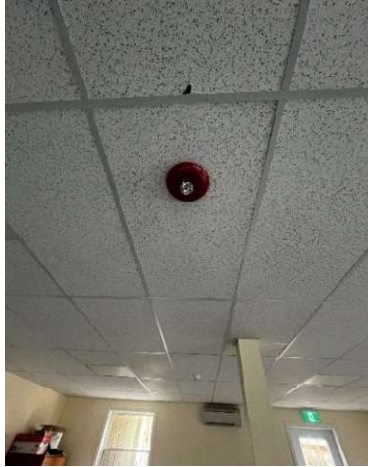
Fire alarms appeared to be more than ten years old. We recommend a qualified fire equipment specialist conduct an assessment as soon as possible to review the current system to ensure it meets code requirements and provides an adequate level of protection. The Afton Community Centre is not equipped with a wet or dry sprinkler system. A fire services professional should be consulted to determine code compliance as well as any requirements for a joint use municipal building.

Figure 37 - Central Alarm Panel

Figure 39 – Smoke Alarm

Project Description	Recommended Budget	Recommended Timing	Comments
Seek expert opinion on replacement date. Potentially replace within the next five years.	\$20,000	2029	No observable issues with smoke alarms.
Obtain inspection on fire suppression system immediately. Seek expert opinion on replacement date.	\$5,000	2033	Fire Suppression system in the kitchen hood appears to be last inspected in 2008.
	\$3,000	2032	There are seven security cameras. Plan replacement based on a 10 year life cycle.
