Rural Municipality of  
**WEST RIVER**

## Building Condition Assessment – Bonshaw Community Center

February 8, 2024

Doc. ID: P0802-1261434335-9 (1.0)

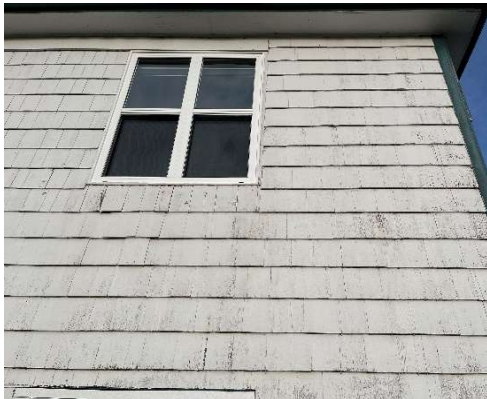
The exterior of the Community Center was in good general condition. The siding and soffits has accumulated some significant grime in some areas as well as showing signs of wear or paint peeling. There are a lot of places where the siding has been breached to allow for the installation of heat pump ducting, conduits to be affixed to the building or other brackets. While these observations do not pose any immediate concern, they could be the location of future moisture penetration.

Figure 1 – Paint Peeled on Siding

Project Description	Recommended Budget	Recommended Timing	Comments
Repair/replace damaged siding and paint the exterior of the building.	\$15,000	2024	Wood panel siding deteriorated in front of the building. Shingles appear sound but need painting.

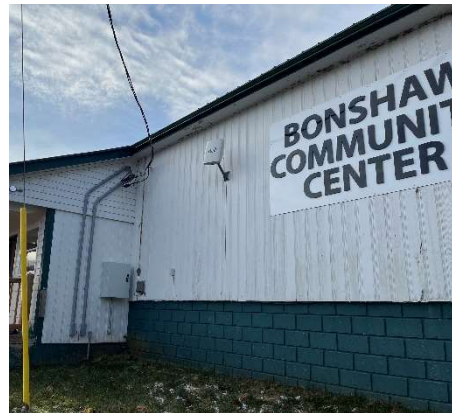
Figure 2 – Wood Siding at End of Life

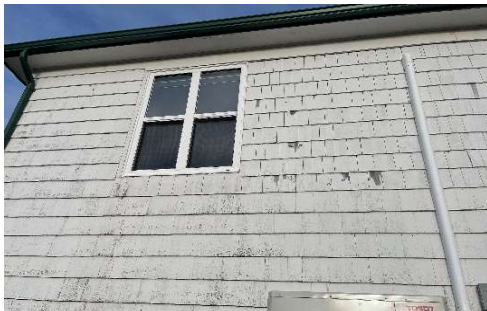
Figure 3 – Paint Peeled on siding

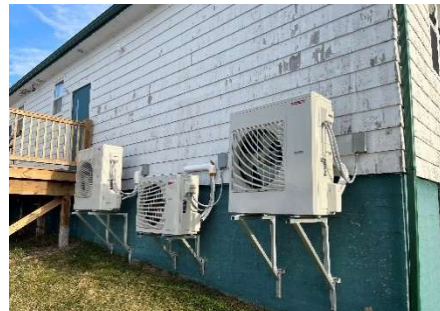
Figure 4 – Paint Peeled on Siding

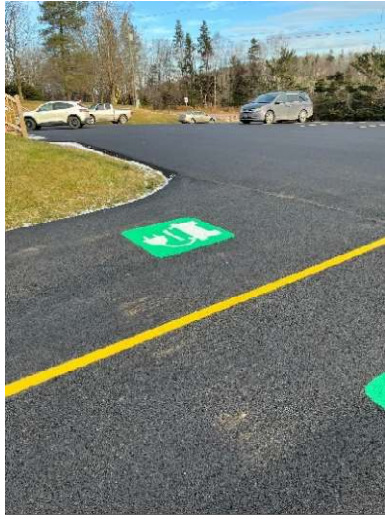
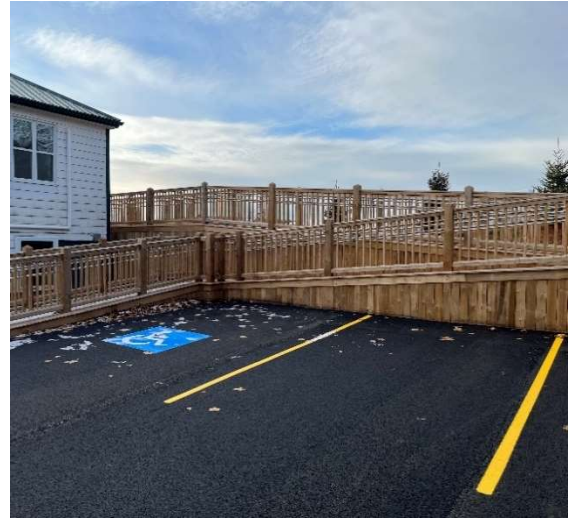
The parking area is in excellent condition and will likely not require maintenance for at least ten years. Painted symbols and lines are all new. Drainage conditions were not observed.

Figure 5 – Main Parking Lot

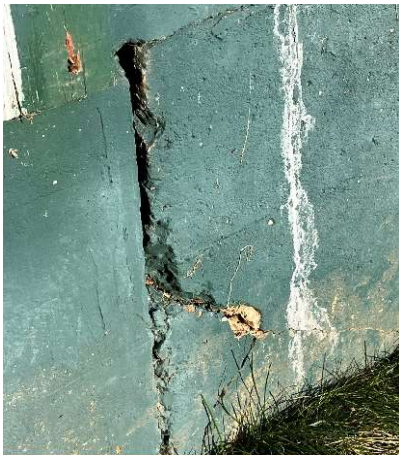
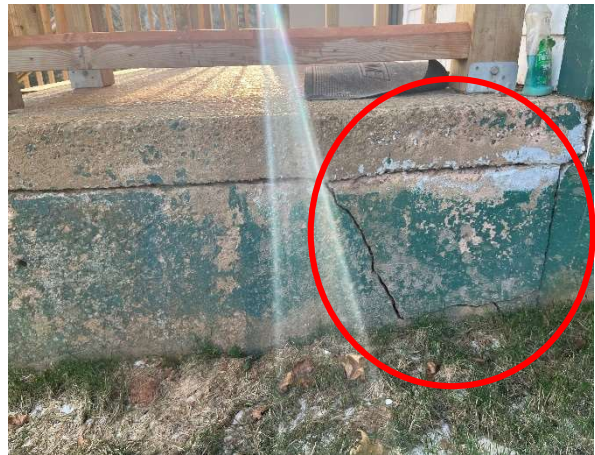
Figure 7 – Crack in Front Steps

Figure 8 – Crack in Front Steps

Project Description	Recommended Budget	Recommended Timing	Comments
Address minor cracks around foundation.	\$TBC	2024	Cracking does not appear significant, but they should be investigated immediately.
Surface patch cracks in front steps concrete to minimize further damage.	\$2,500	2024	Minor cracking of porch steps slab. Steps might need to be completely replaced within the next 10 years.

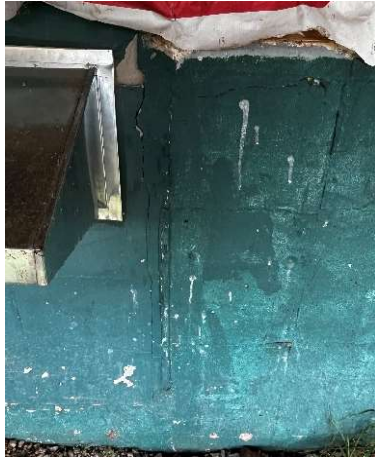
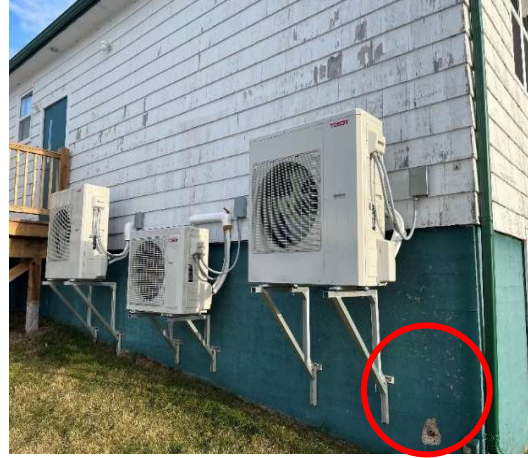
The building structure is a wood frame construction on a concrete foundation. Other than the work recommended for the siding mentioned above, the exterior of the building appears to be in good condition. The concrete foundation is in fair condition with some minor areas observed that require patching.

Figure 9 – Minor Cracks

Figure 10 – Minor Cracks

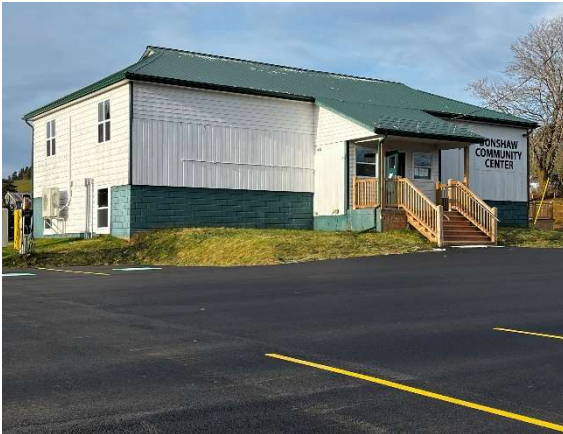
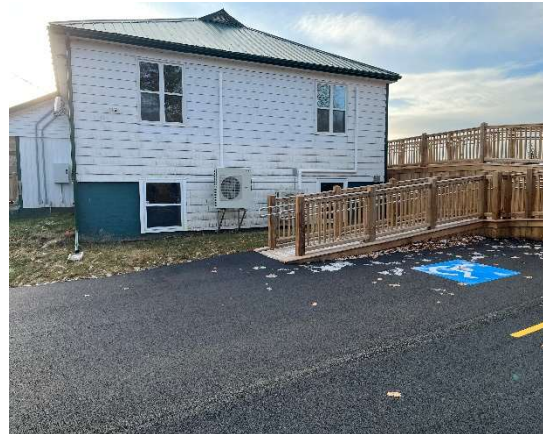
The steel roof was observed from ground level and appeared to be in good condition. No evidence of leaking was observed inside the building.

Figure 11 – Steel Roof

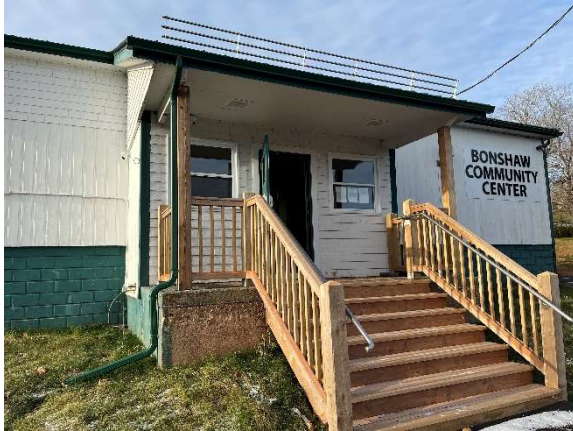
There are two entrances to the Bonshaw Community Center: one in the front, and one in the back of the building. The steps and ramps to these entrances are in excellent condition and require no maintenance in the short-term.

Figure 13 – Front Steps to Front Door

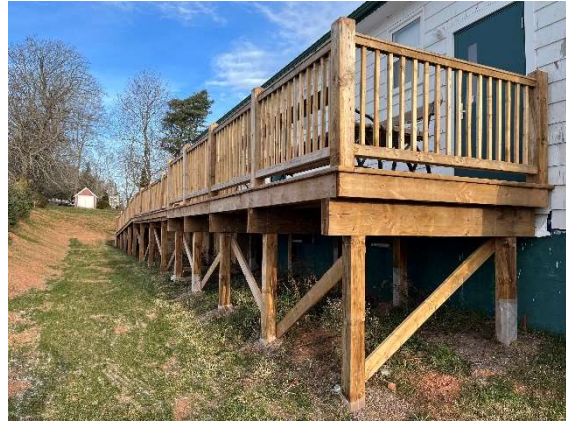
Figure 14 – Accessible Ramp to Back Door

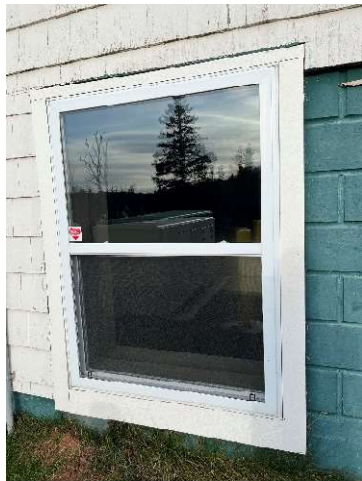
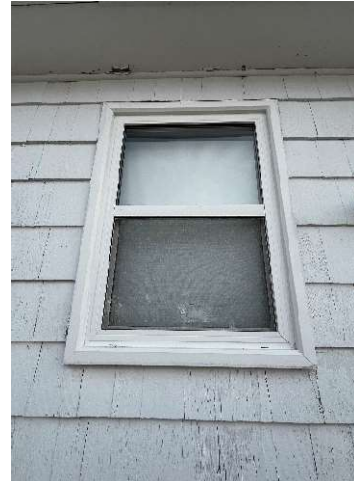
The windows and doors are all new and are estimated to have a life cycle of at least 25 years.

Figure 15 – New Window

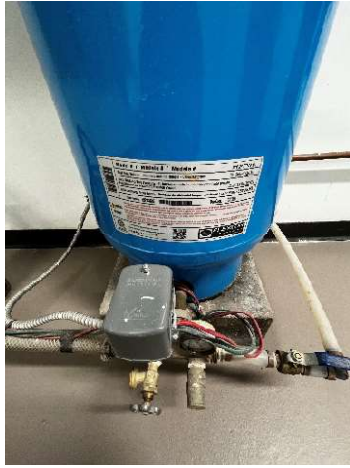
The tanks and plumbing components for water supply and heating are all in excellent condition.

Figure 17 – Expansion Tank

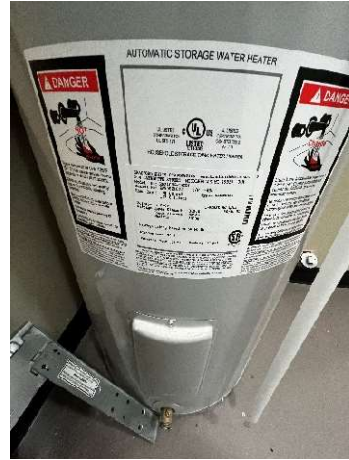
Figure 18 – Hot Water Tank

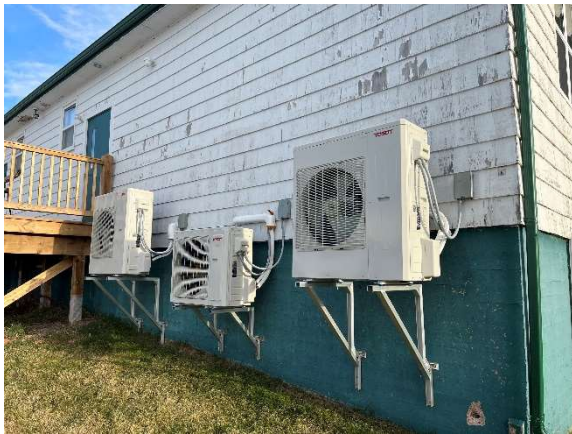
There are six new heat pumps providing heating and cooling to the building. Heat pumps are expected to last between 10 to 15 years before breakdowns and repairs become necessary. It is recommended that planned replacement for these systems be built into the ongoing capital plan for Bonshaw Community Center.

Figure 19 – Heat Pumps

Project Description	Recommended Budget	Recommended Timing	Comments
Replace heat pumps.	\$56,000	2034	Heat pumps installed in 2022.

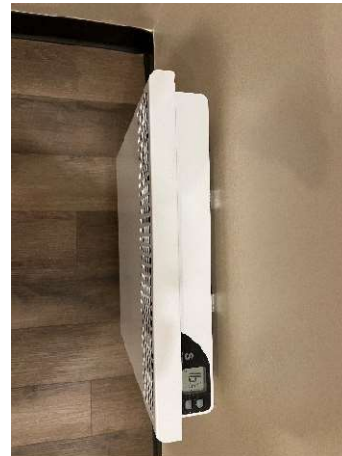
Figure 20 – Electric Radiators

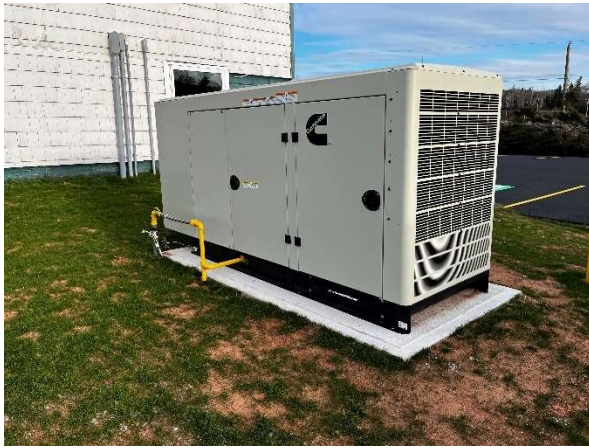
The Cummins propane generator was installed in 2022 and is in excellent condition. It has an expected life cycle of 20-25 years. It is recommended that RMWR follow the supplier's annual maintenance program.

Figure 21 – Cummins Generator

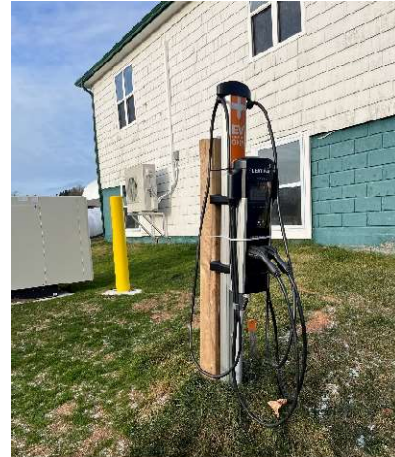
The Electric Vehicle charger was installed in 2022 and is in good condition.

Figure 22 – Charging Station for Electrical Vehicles

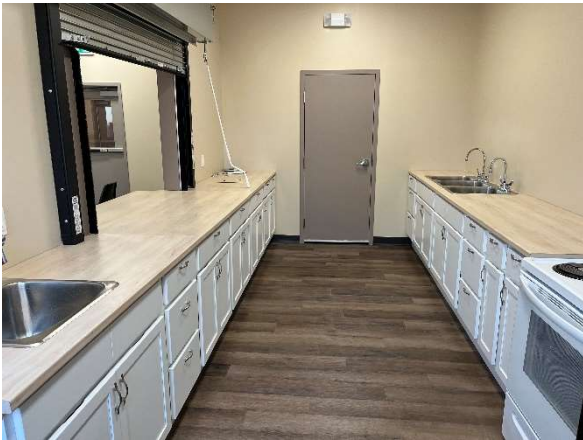
The kitchen is in excellent condition. The counters and the mini rollup access window are all new as of 2022. There is a commercial grade refrigerator refrigerator/display case. Most of the kitchen equipment is domestic grade equipment.

Figure 23 – Kitchen

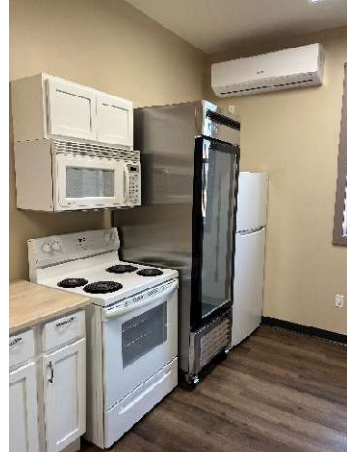
Figure 24 – Kitchen Appliances

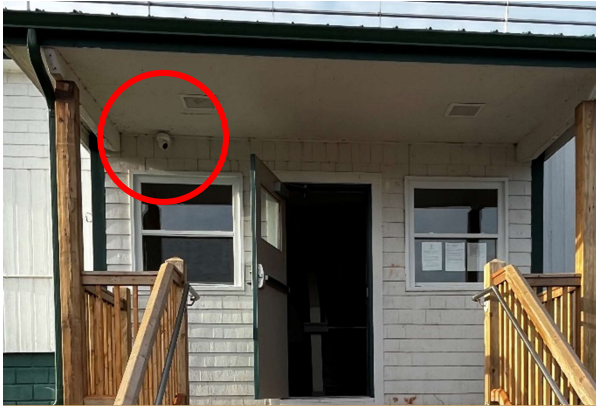
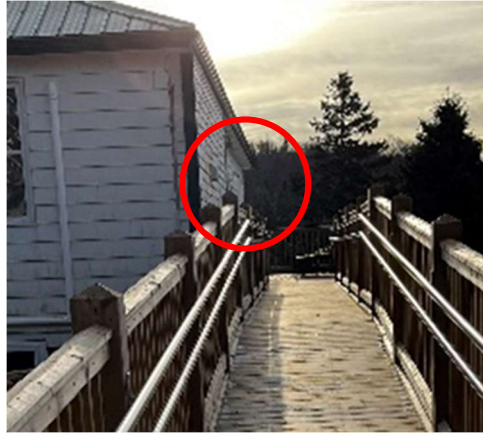
Figure 25 – Security Camera

Figure 26 – Security Camera

Project Description	Recommended Budget	Recommended Timing	Comments
Obtain expert opinion on replacement date.	\$3,000	2032	No observable issues with smoke alarms.
Replace security cameras.	\$2,500	2032	There are three security cameras. Plan replacement based on a 10 year life cycle.
