Rural Municipality of
WEST RIVER

Building Condition Assessment – Afton Community Centre

February 8, 2024

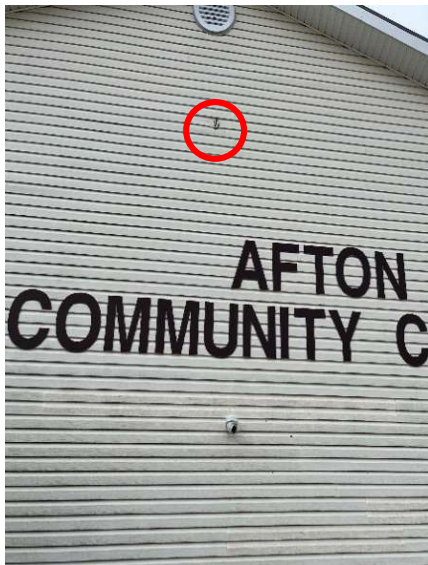
Figure 1 – Front Exterior

In general, the exterior of the Community Centre is in good condition. The siding has accumulated some significant grime in some areas as well as showing signs of wear or paint peeling. There are numerous locations where the siding has been breached to allow for the installation of heat pump ducting, brackets, and conduit to be affixed to the building. While these observations do not pose any immediate concern, they could be the location of future moisture penetration and it is recommended that a detailed visual inspection and reapplication of caulking should be considered as soon as possible and on annual basis moving forward. A few possible concern locations are identified in the following images.

Project Description	Recommended Budget	Recommended Timing	Comments
Check entire building exterior, close any cracks or separations in siding or cladding and caulk around any suspected gaps. Power wash building and assess if painting is warranted.	\$2,500	2024	Siding is dirty and has some paint peeling. Several locations observed where the siding has been penetrated by affixed brackets, installed conduits or wind damage.
Be prepared to replace siding at the end of the 40 year life cycle.	\$50,000	2030	Siding showing evidence of cracking and fading.

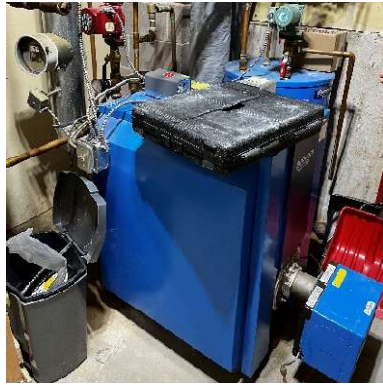
Figure 16 – Buderus Boiler

Project Description	Recommended Budget	Recommended Timing	Comments
Replace domestic water pump and tank within the next two years.	4,500	2025	Pump and tank for well water are rusting.
Replace existing tank with a fiberglass oil tank within the next four years. Consult insurance provider.	\$4,000	2027	The oil tank was manufactured in 2007.
Expect to replace in the next ten years. Seek expert opinion.	\$10,000	2034	Buderus Cast Iron Oil Boiler, appears to be in good condition.
Expect to replace in the next ten years. Seek expert opinion.	2,5000	2034	Buderus water tank appears to be in good condition.

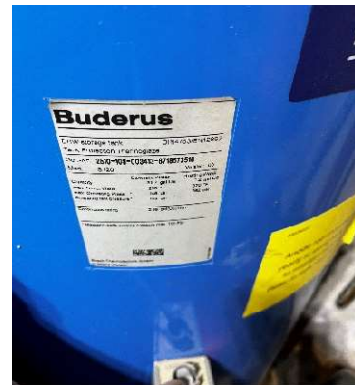
There is a steel oil tank currently inside the building that is difficult to access. The tag indicates a fabrication date of 2007. This tank will need to be replaced with another tank by 2027, and that should ideally be installed on the outside of the building. It is recommended that the building's insurance provider be consulted.

Figure 17 – Tank Tag (MFD April 2007)

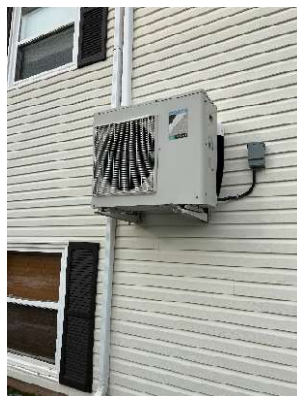
Figure 18 – East Side

There are a total of seven heat pumps: three on the East side of the building and four on the West side. Five pumps were installed in 2017 and two in 2022. All are in good condition. Heat pump life cycles vary but 10-15 years is a typical period and planning for replacement is recommended.

Project Description	Recommended Budget	Recommended Timing	Comments
Perform yearly maintenance to optimize life and performance of heat pump. Estimated replacement year 2029.	\$30,000	2029	Heat pumps are in good condition.
Perform yearly maintenance to optimize life and performance of heat pump. Estimated replacement year 2029.	\$12,000	2034	Heat pumps are in good condition.

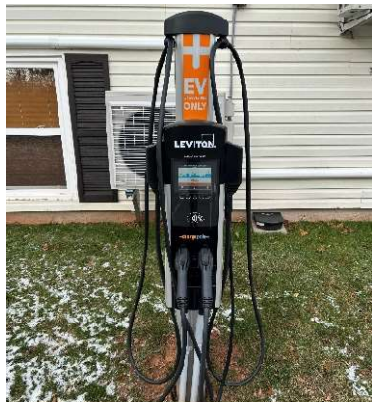
The Electric Vehicle charger was installed in 2022 and is in good condition.

Figure 22 - Charging Station for Electrical Vehicles.

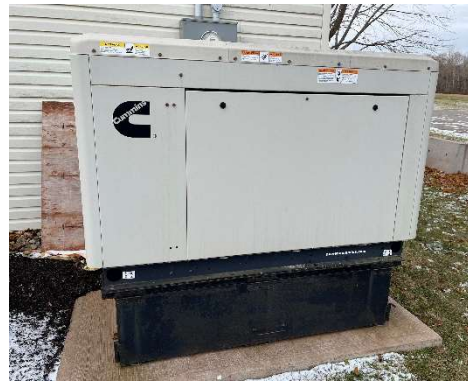
The Cummins propane generator is in good condition. It has an expected life cycle of 20-25 years. It is recommended that RMWR follow the supplier’s annual maintenance program.

Figure 23 – Cummins Propane Generator

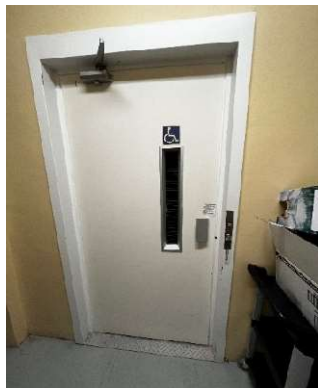
Figure 26 - Elevator Entry

Afton Community Centre is equipped with a small hydraulic cable elevator for accessibility between floors. The manufacturer date on the panel case indicates a year of manufacture of 1996 and a suggested replacement year of 2001. The elevator is currently at the 28-year point in its service life; however, it is unlikely that this elevator has experienced heavy use. While the elevator and hydraulic pump appeared to be in good condition, a serviceability assessment for this device is beyond the scope of this report and a qualified elevator service provider should provide a safety assessment on the continued use of this elevator.

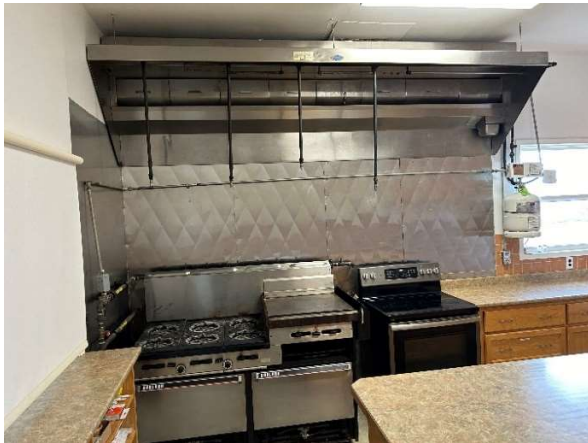
range hood fire suppression tank shows an inspection date of 2008, this should be inspected by a qualified person immediately if the kitchen is still in use.

Figure 28 - Kitchen Range and Fire Suppression

Project Description	Recommended Budget	Recommended Timing	Comments
Seek expert opinion on replacement date. Potentially replace within the next five years.	\$20,000	2029	No observable issues with smoke alarms.
Obtain inspection on fire suppression system immediately. Seek expert opinion on replacement date.	\$5,000	2033	Fire Suppression system in the kitchen hood appears to be last inspected in 2008.
	\$3,000	2032	There are seven security cameras. Plan replacement based on a 10 year life cycle.

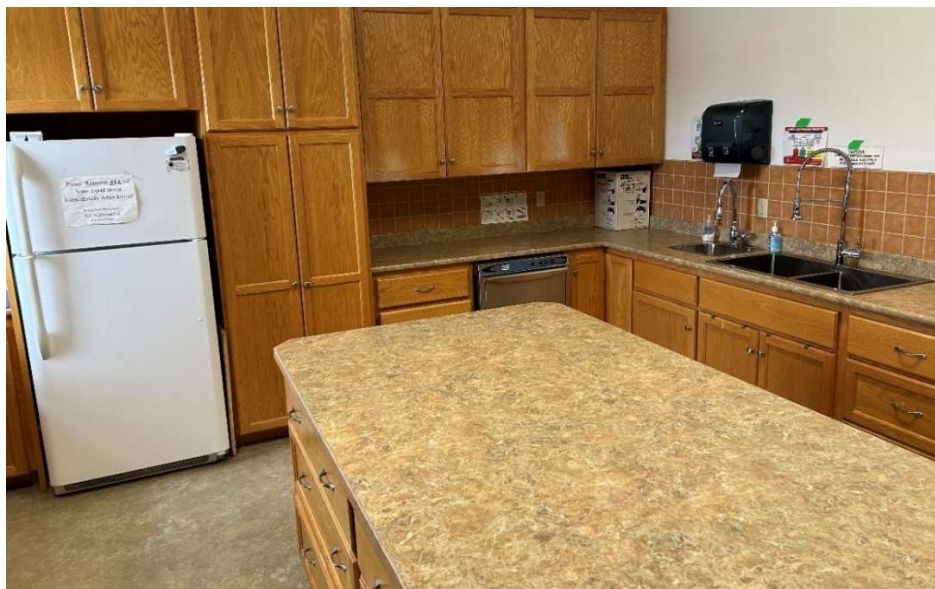
The kitchen is in good condition. The kitchen has the components necessary to operate as a commercial kitchen. The griddle/stove/oven and range hood are in good condition (installed in 2018) but would require assessment by kitchen equipment experts to provide a definitive end of life recommendation. The

Figure 30 - Kitchen with Residential Fridge and Commercial Dish Washer

Project Description	Recommended Budget	Recommended Timing	Comments
Downstairs kitchen plan refurbishment within the next five years	\$5,000	2029	The downstairs kitchenette/bar millwork is operational but needs updating.
Main kitchen, plan refurbishment within the next ten years.	\$20,000	2033	Main kitchen millwork / sink in good condition.

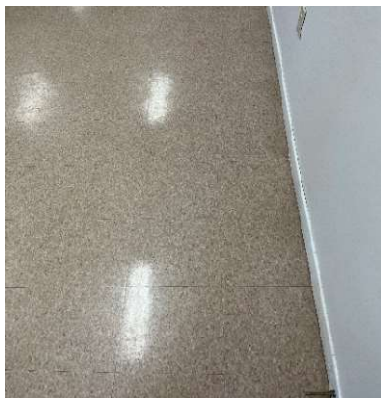
The floors appear to be fair condition. There is significant wearing in the side entrance hallway as well as in in the downstairs multipurpose room. The kitchen flooring is showing some signs of cracking and could be replaced now. The painted wooden stairs are still fully functional but look worn due to the paint being chipped away. The floor maintenance is likely to be one of the larger maintenance items in the coming years. If the floors will be replaced, a multi-year approach would help to make the refurbishment more manageable. By planning the repairs over two years, the financial and operational impacts can be more easily managed. Due to the cost associated with the floor replacements, it is recommended that the floors not be replaced until a decision has been made regarding the future of the Afton Community Centre.

Figure 31 - Flooring Sample – Best Condition.

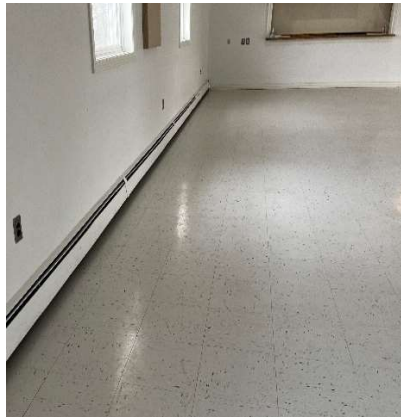
Figure 35 - Upstairs Multipurpose Room Floor - Light Wear Only

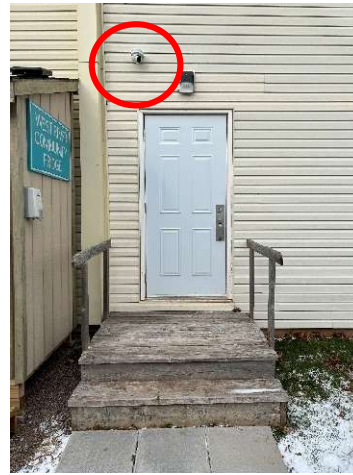
Figure 40 – Security Cameras
